ENTIAT

CO-OPERATIVE RIVER BASIN STUDY

Cooperative River Basin Study

April 1979

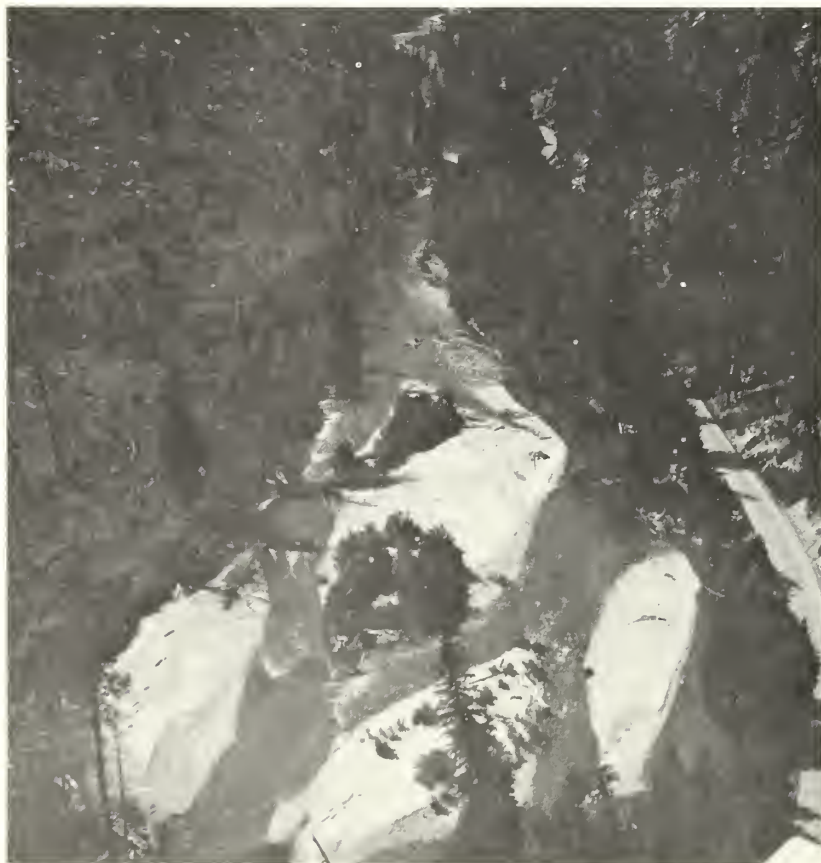
Aerial view of Upper Entiat River typical of stream reaches within the 1970 Burn. Note debris deposition and channel braiding. Much of this sediment moves further downstream during each annual flood peak.

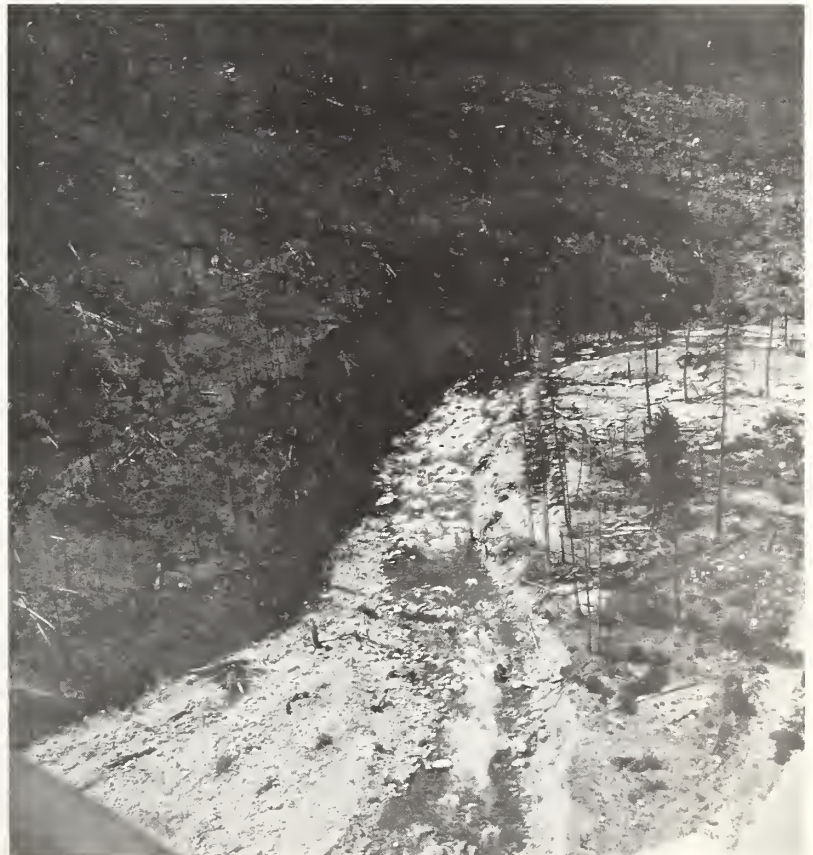
Unstable river bank and bottom contributes about 200 tons of fluvial sediment per mile per year at this reach.

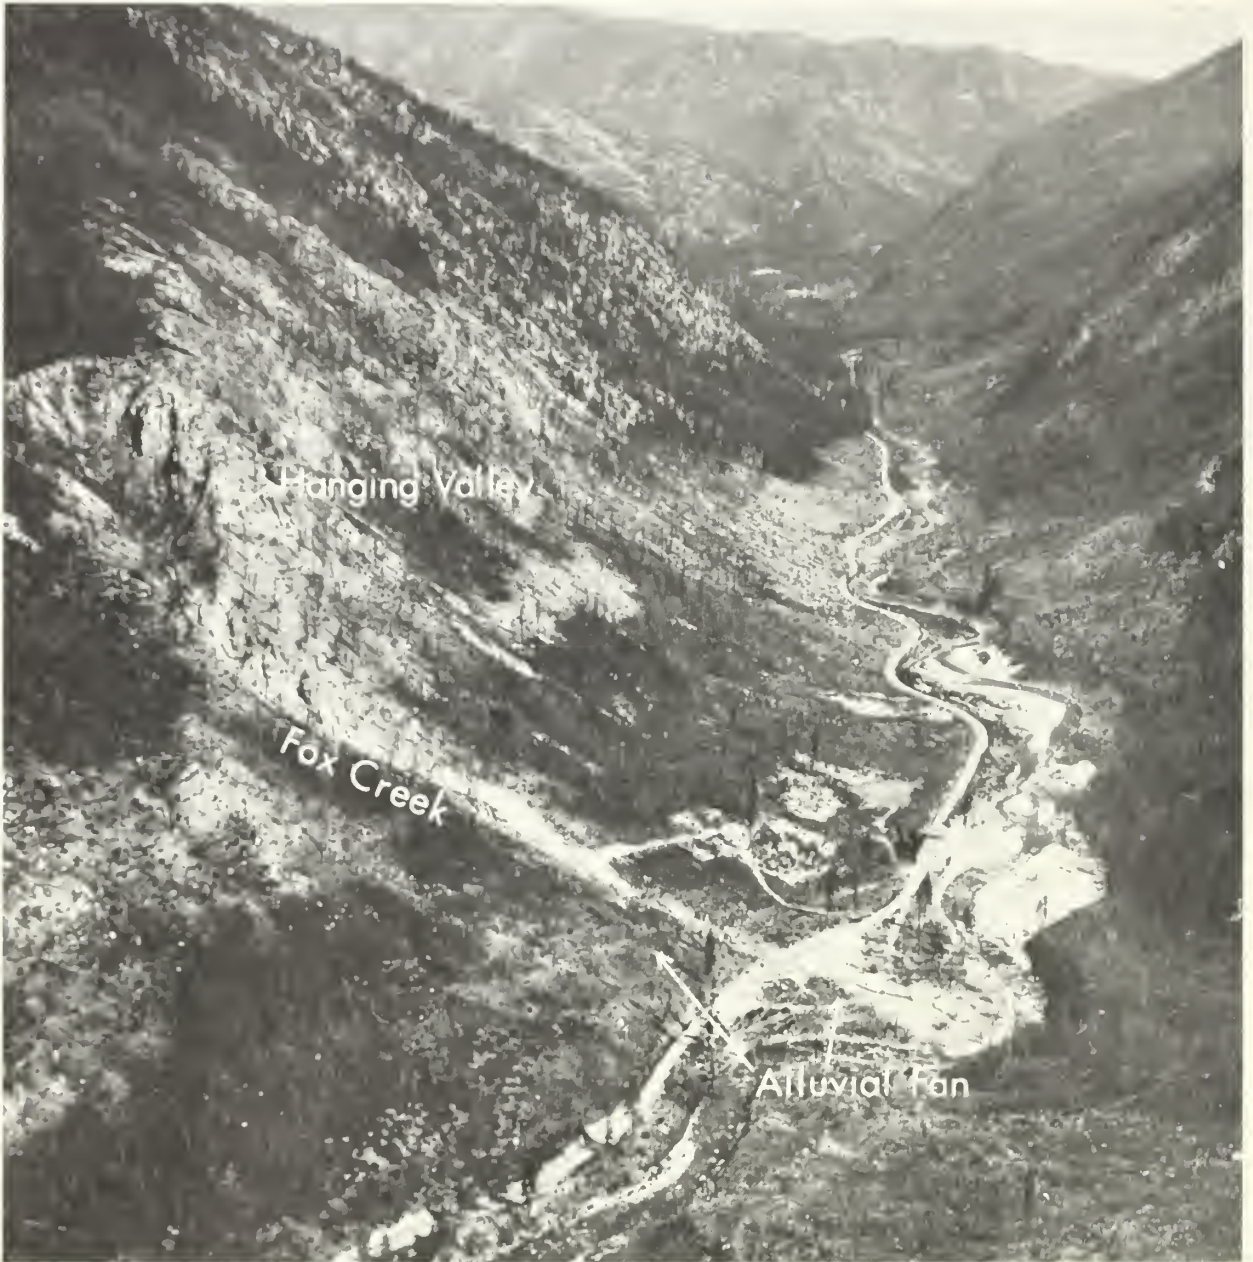
The glacier-carved Entiat Valley looking downriver from Fox Creek. Fox Creek flows from a hanging valley and crosses an alluvial fan before it joins the Entiat.

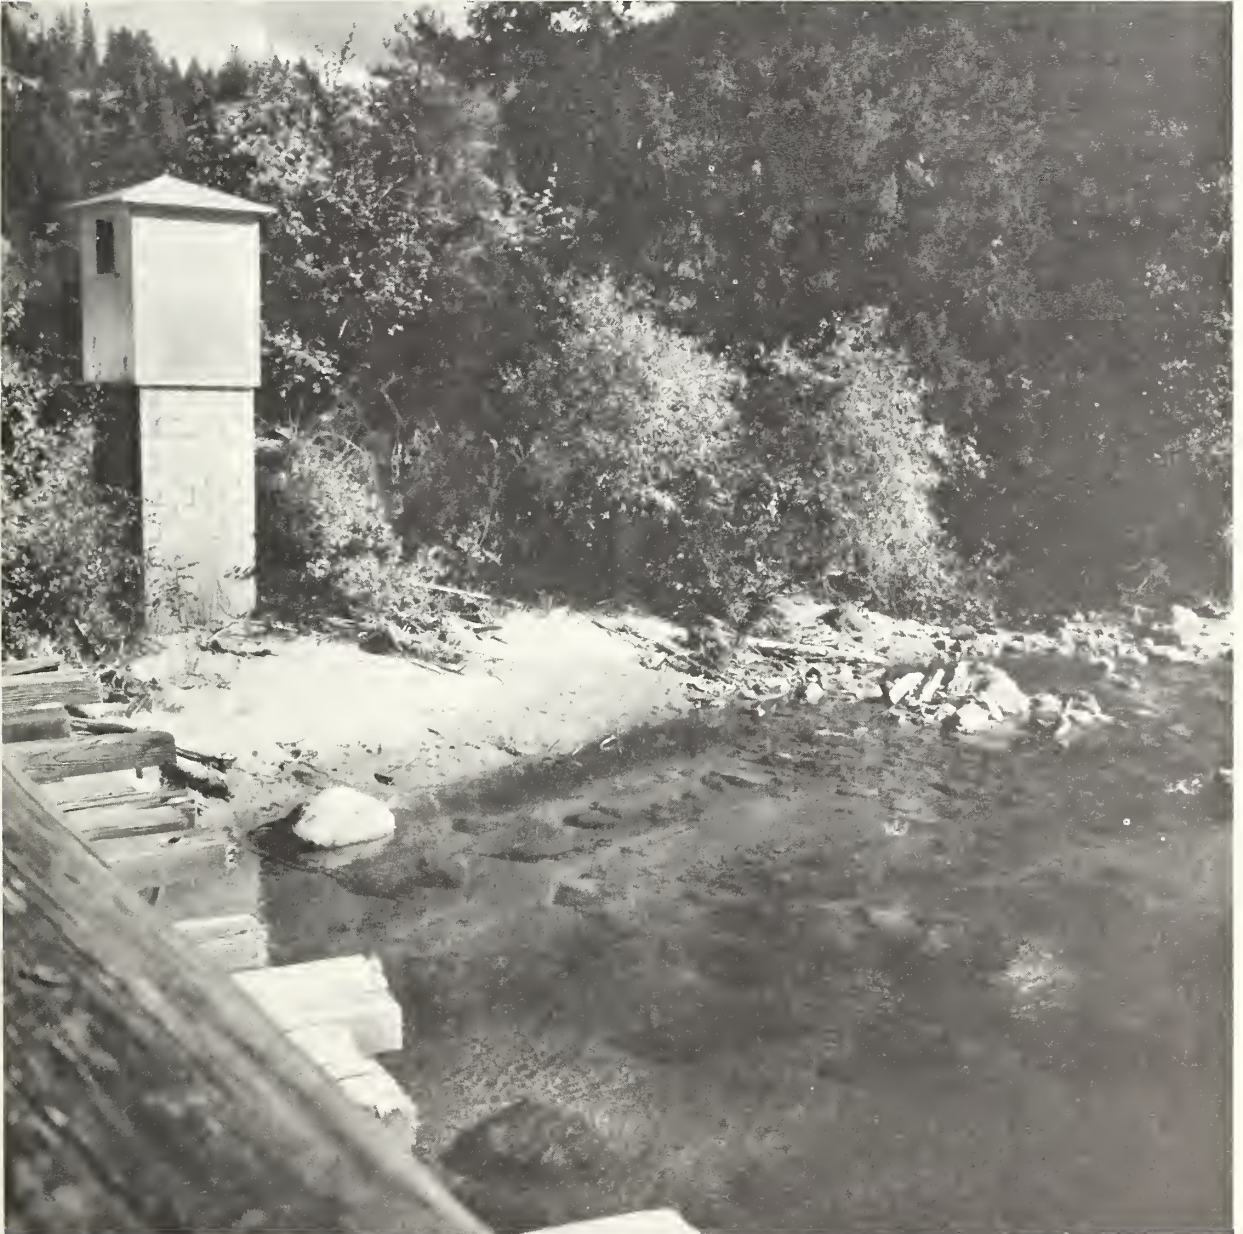
U.S. Geologic Survey stream flow gaging station on Main Entiat River. Note fine partical sediment accumulation.

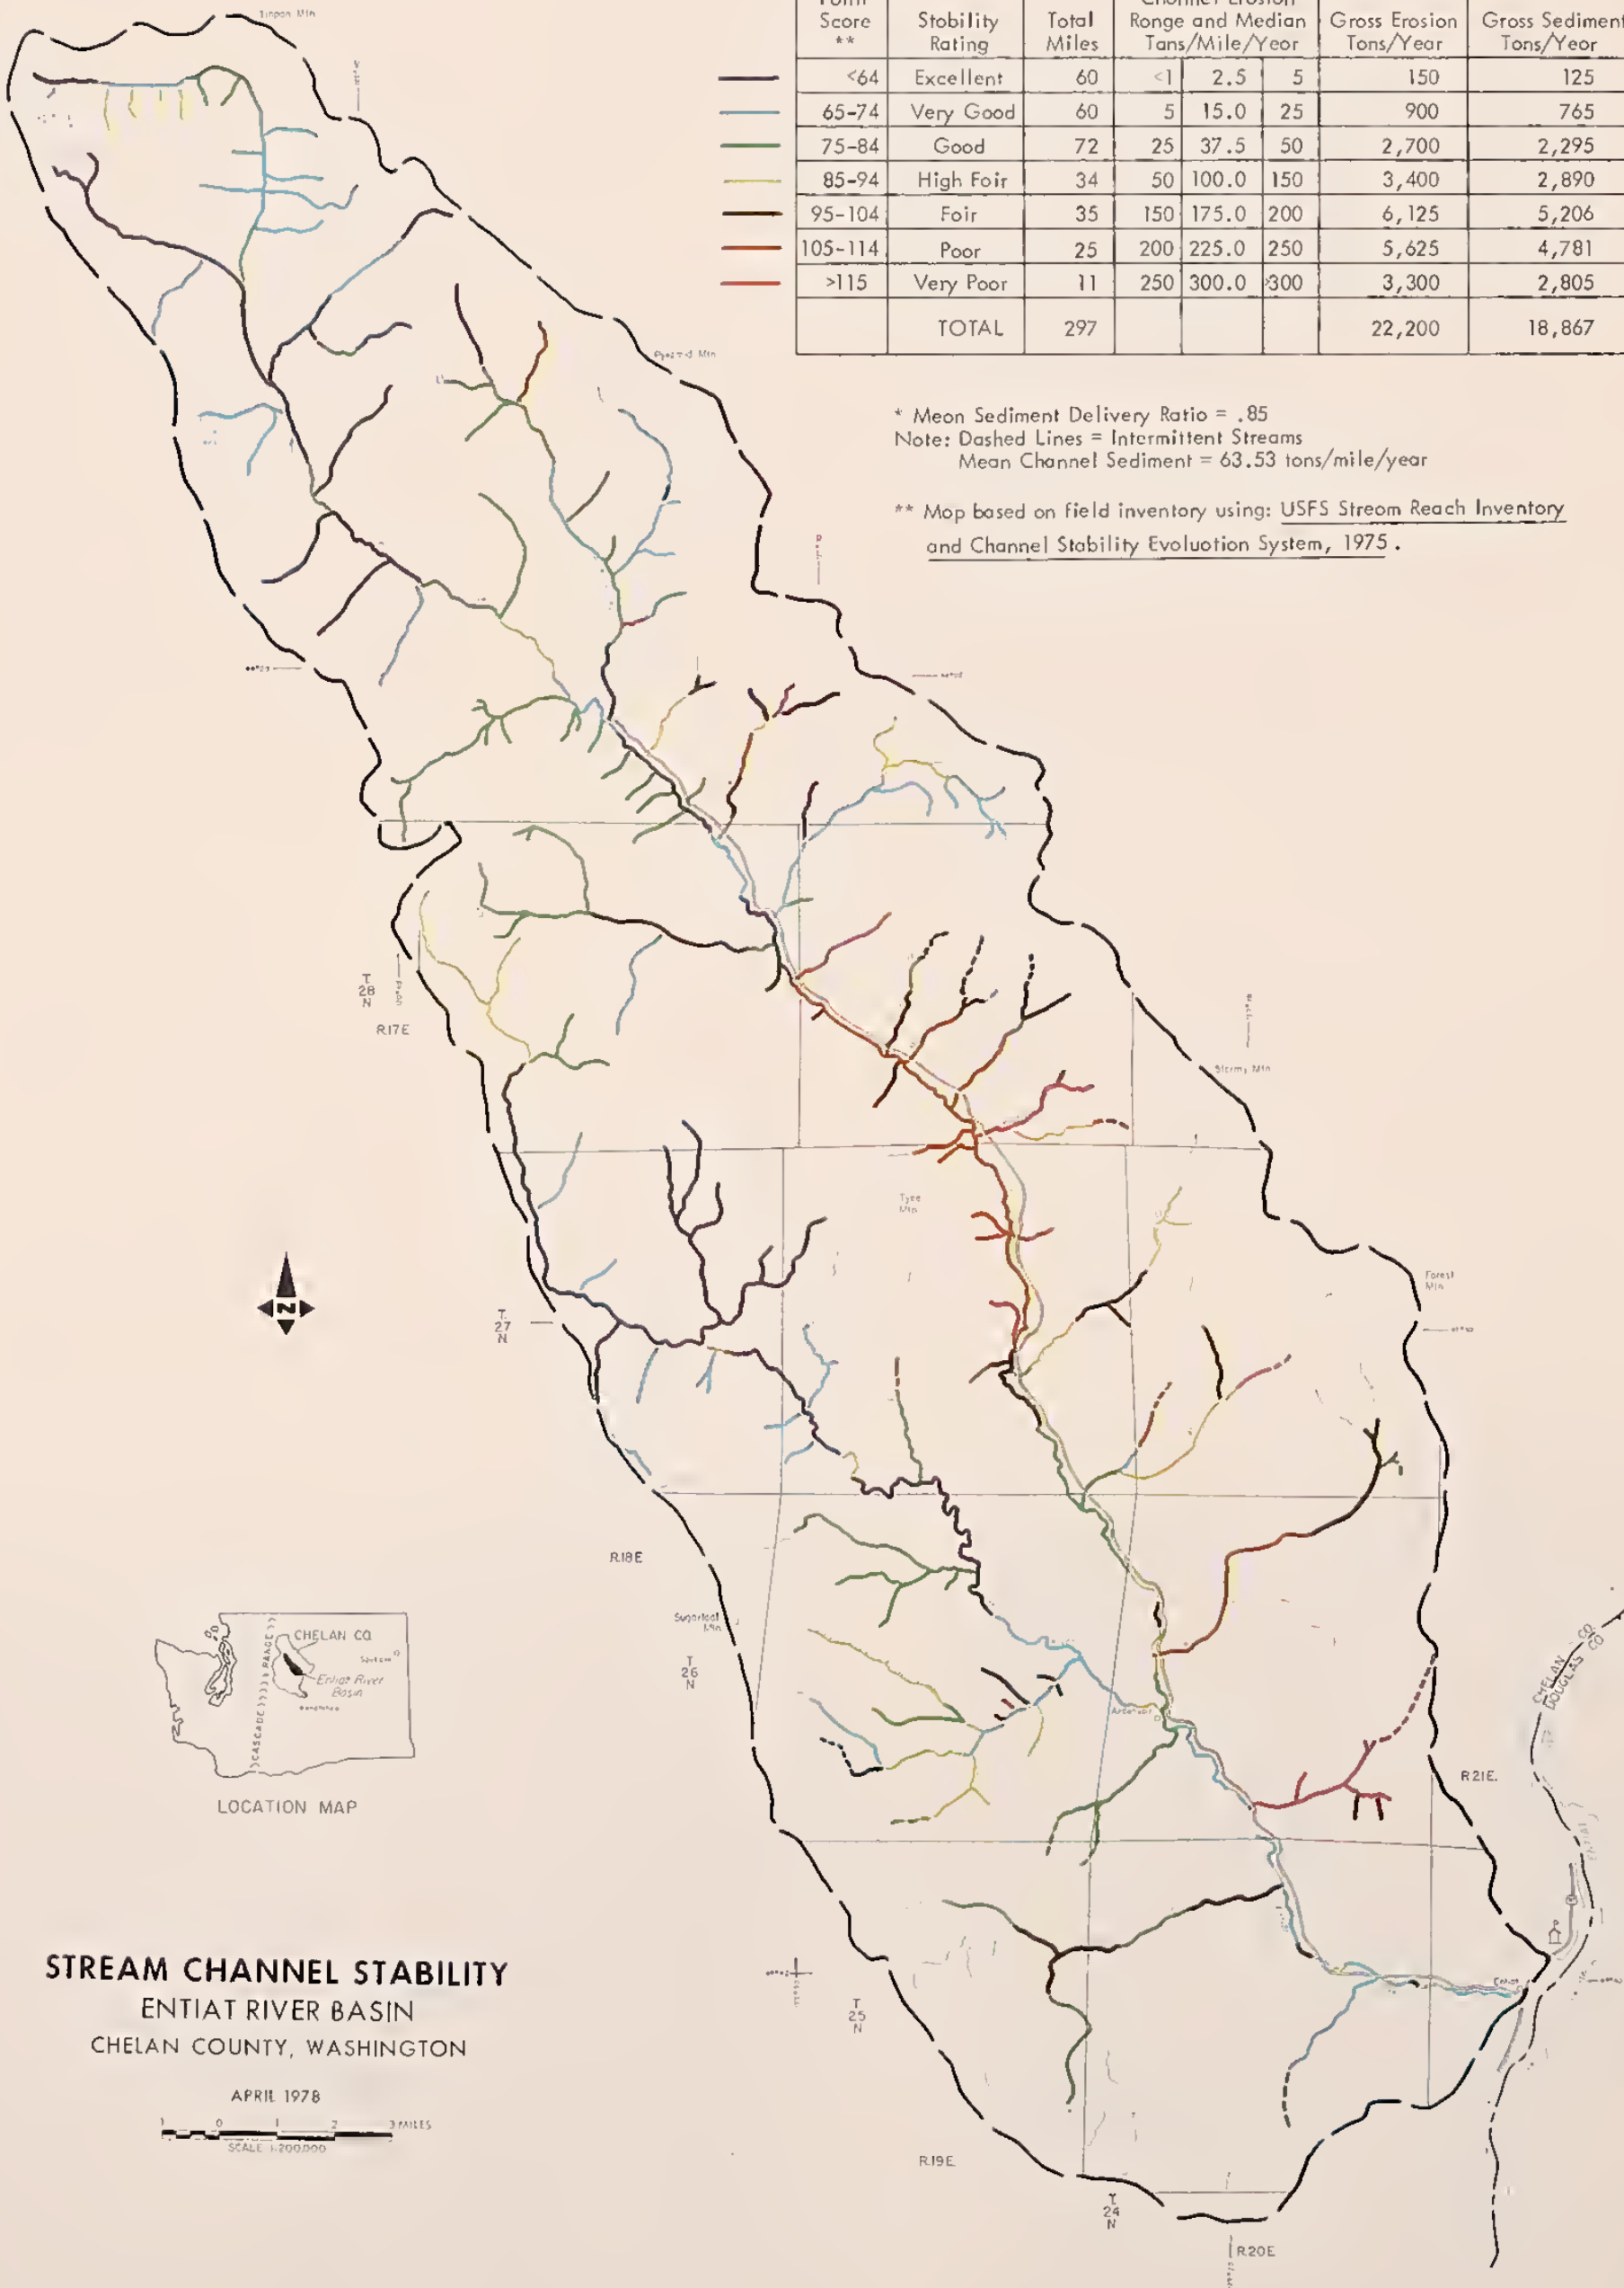
STREAM CHANNEL STABILITY
ENTIAT RIVER BASIN
CHELAN COUNTY, WASHINGTON

** Map based on field inventory using: USFS Stream Reach Inventory and Channel Stability Evolution System, 1975.

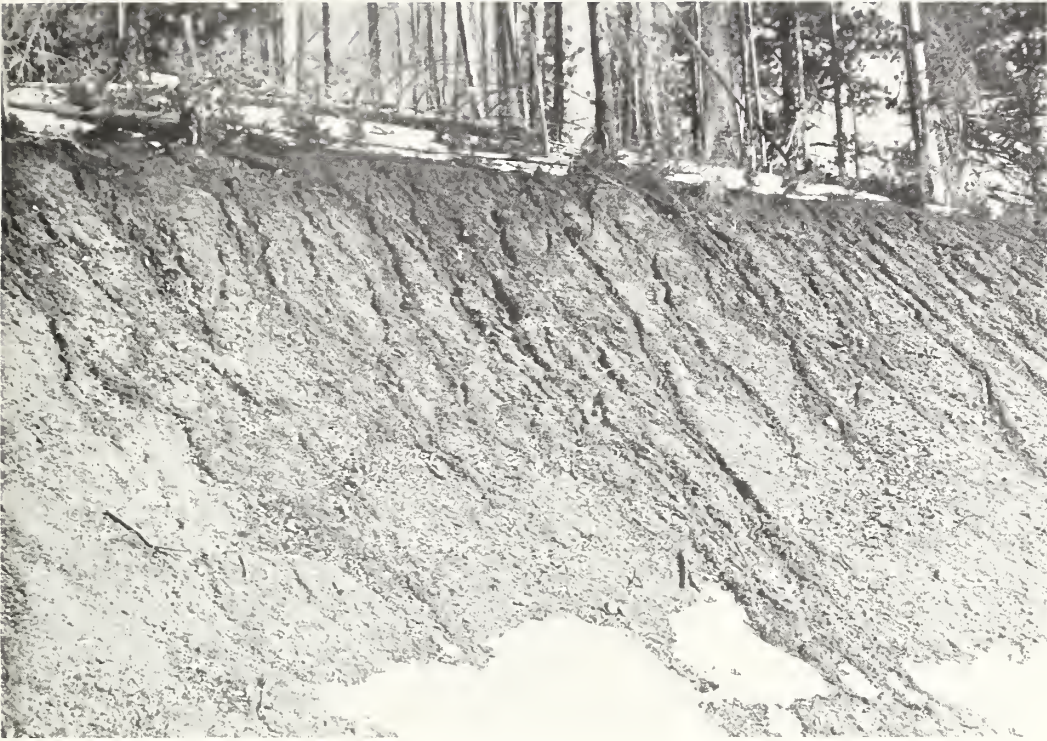
Rill erosion on forest road in the Mad River area.

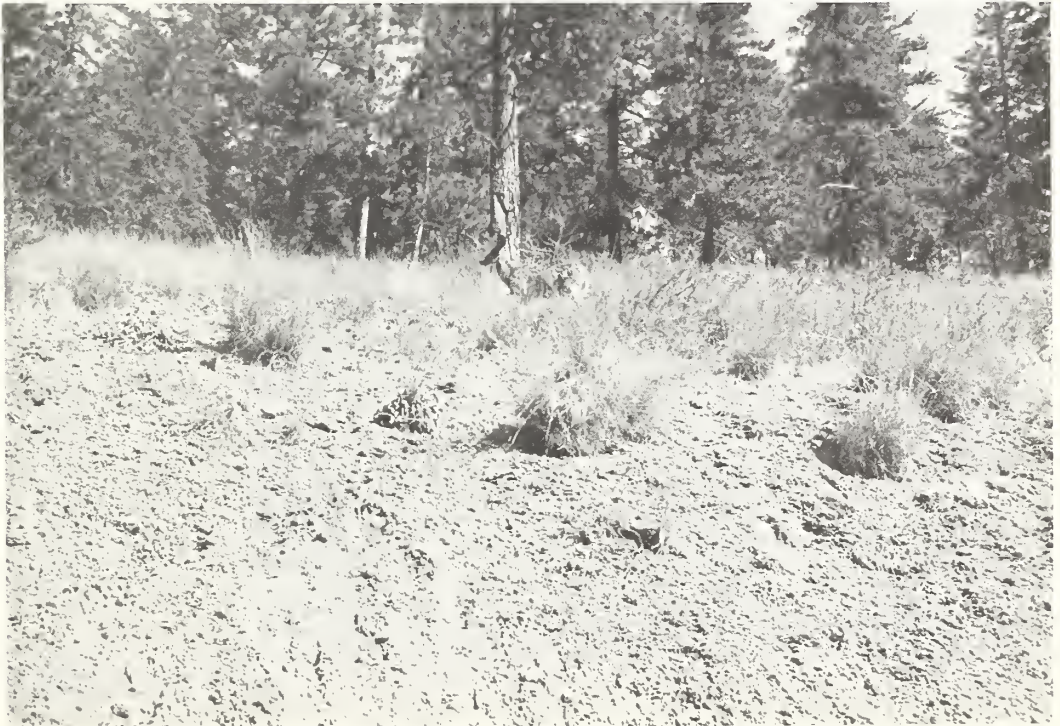
*Sheet erosion pedestals on road cut slope in Mad River area.
Note deer which have increased in numbers since 1970 fire.*

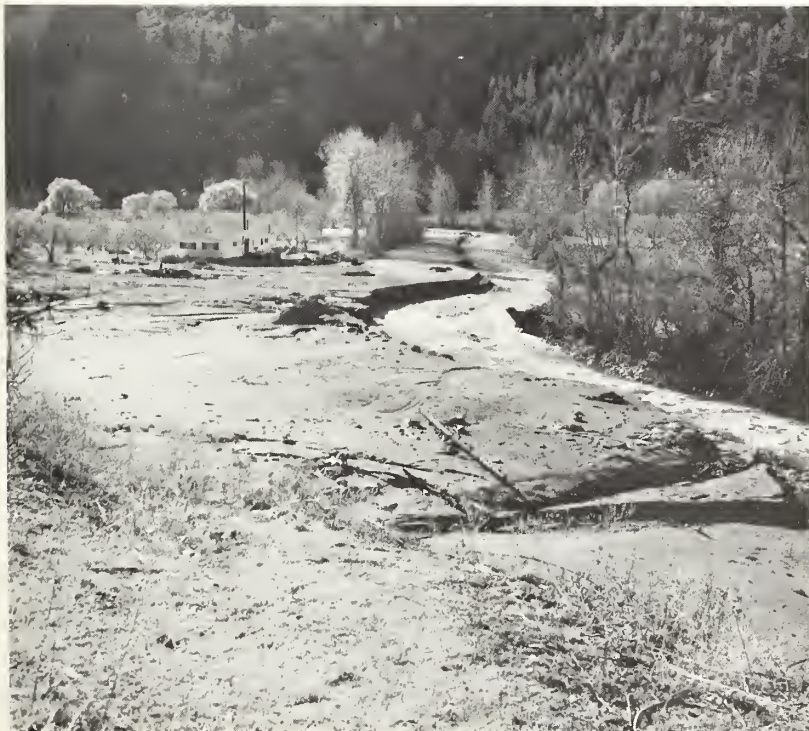
Sedimentation and bank scour following the 1977 Crum Canyon floods.

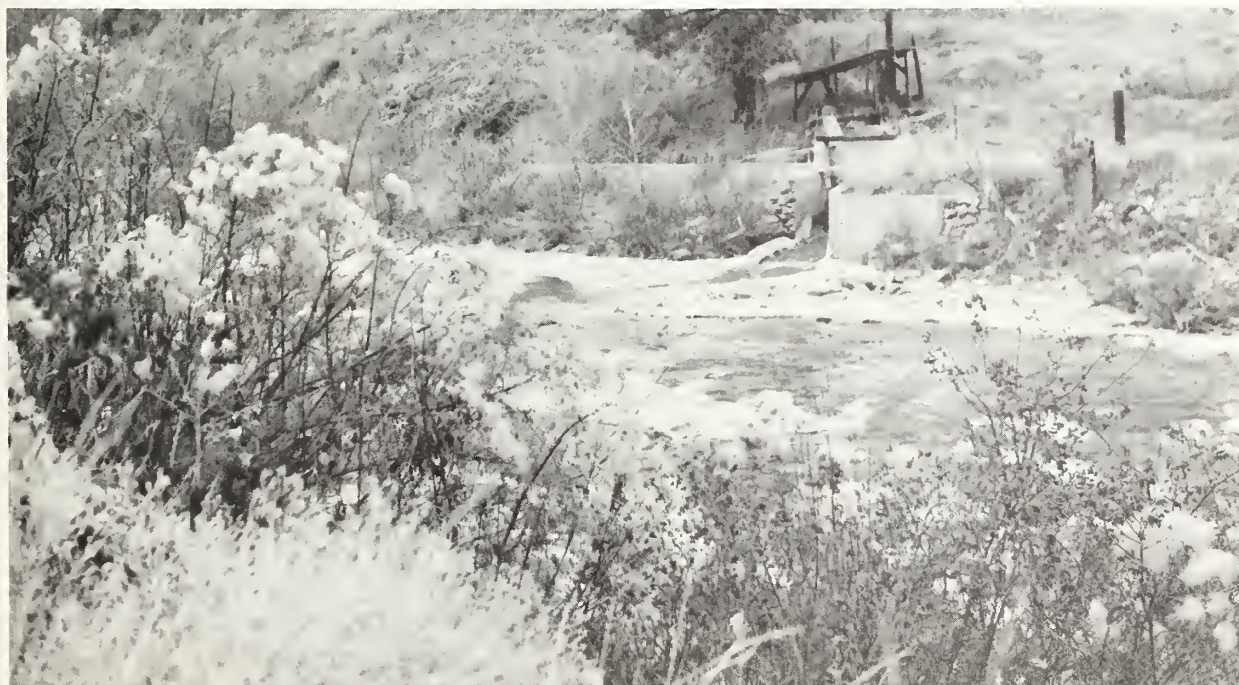
Irrigation water diversion on the Lower Entiat. Sediment has caused costly maintenance to irrigation systems since the 1970 fire and 1972 flood.

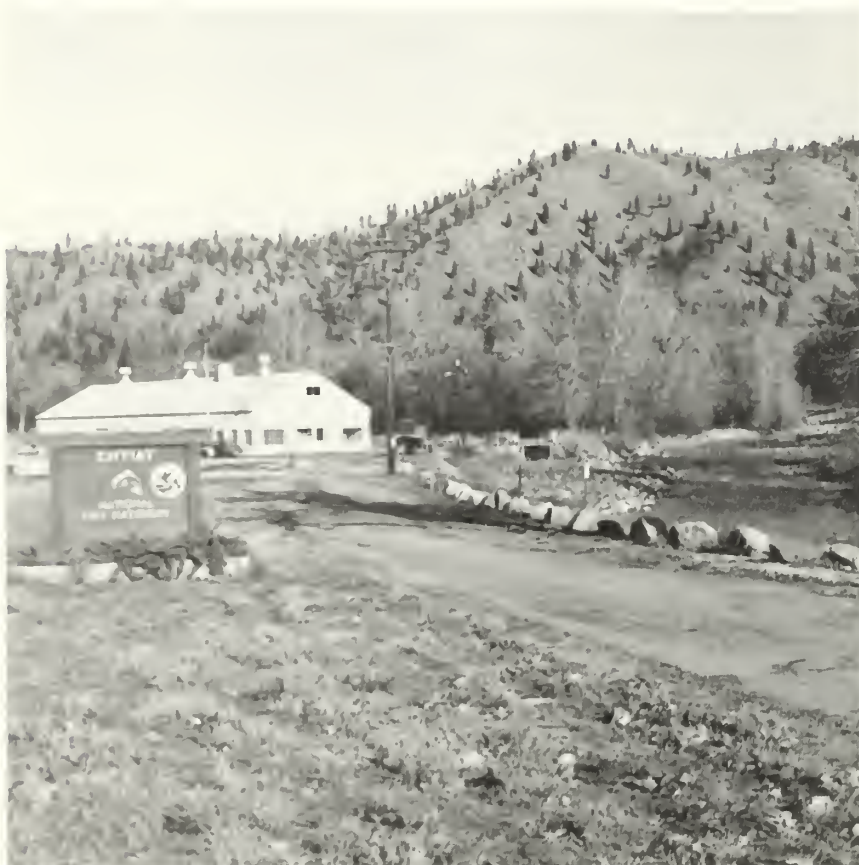
Federal fish hatchery in Lower Entiat takes some of its water from the river. Major fish losses have occurred due to river sediment. Hatchery plans to change to a groundwater source of clean water.

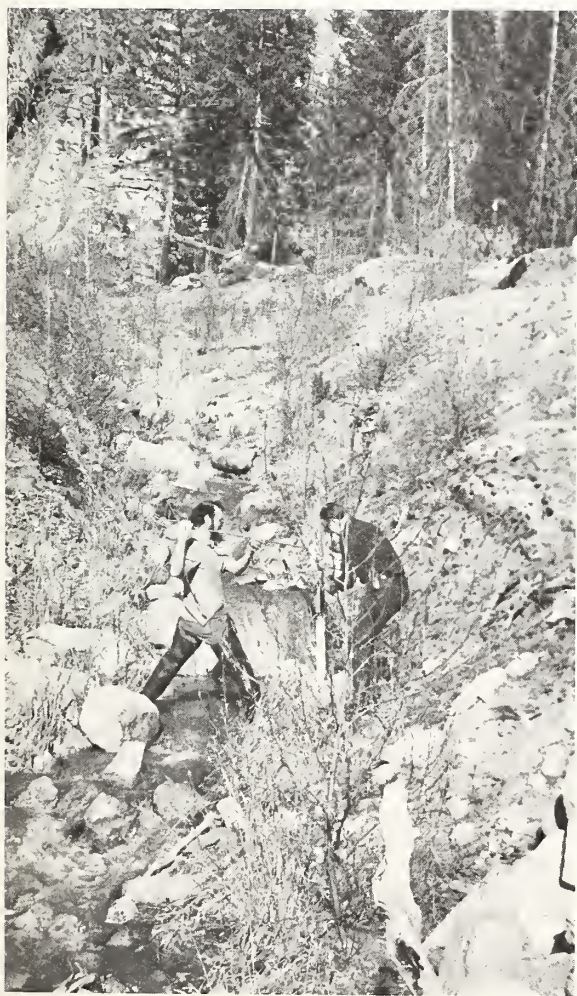
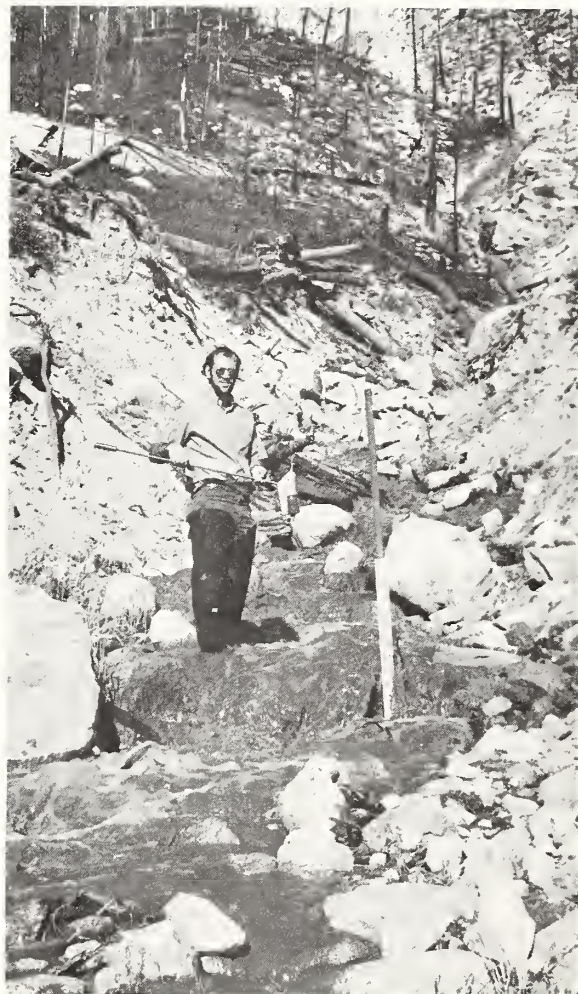
Hydrologists collect sediment sample from a burned out tributary of the Entiat River using a hand held depth integrated sediment sampler. Note staff gage for stream flow correlation.

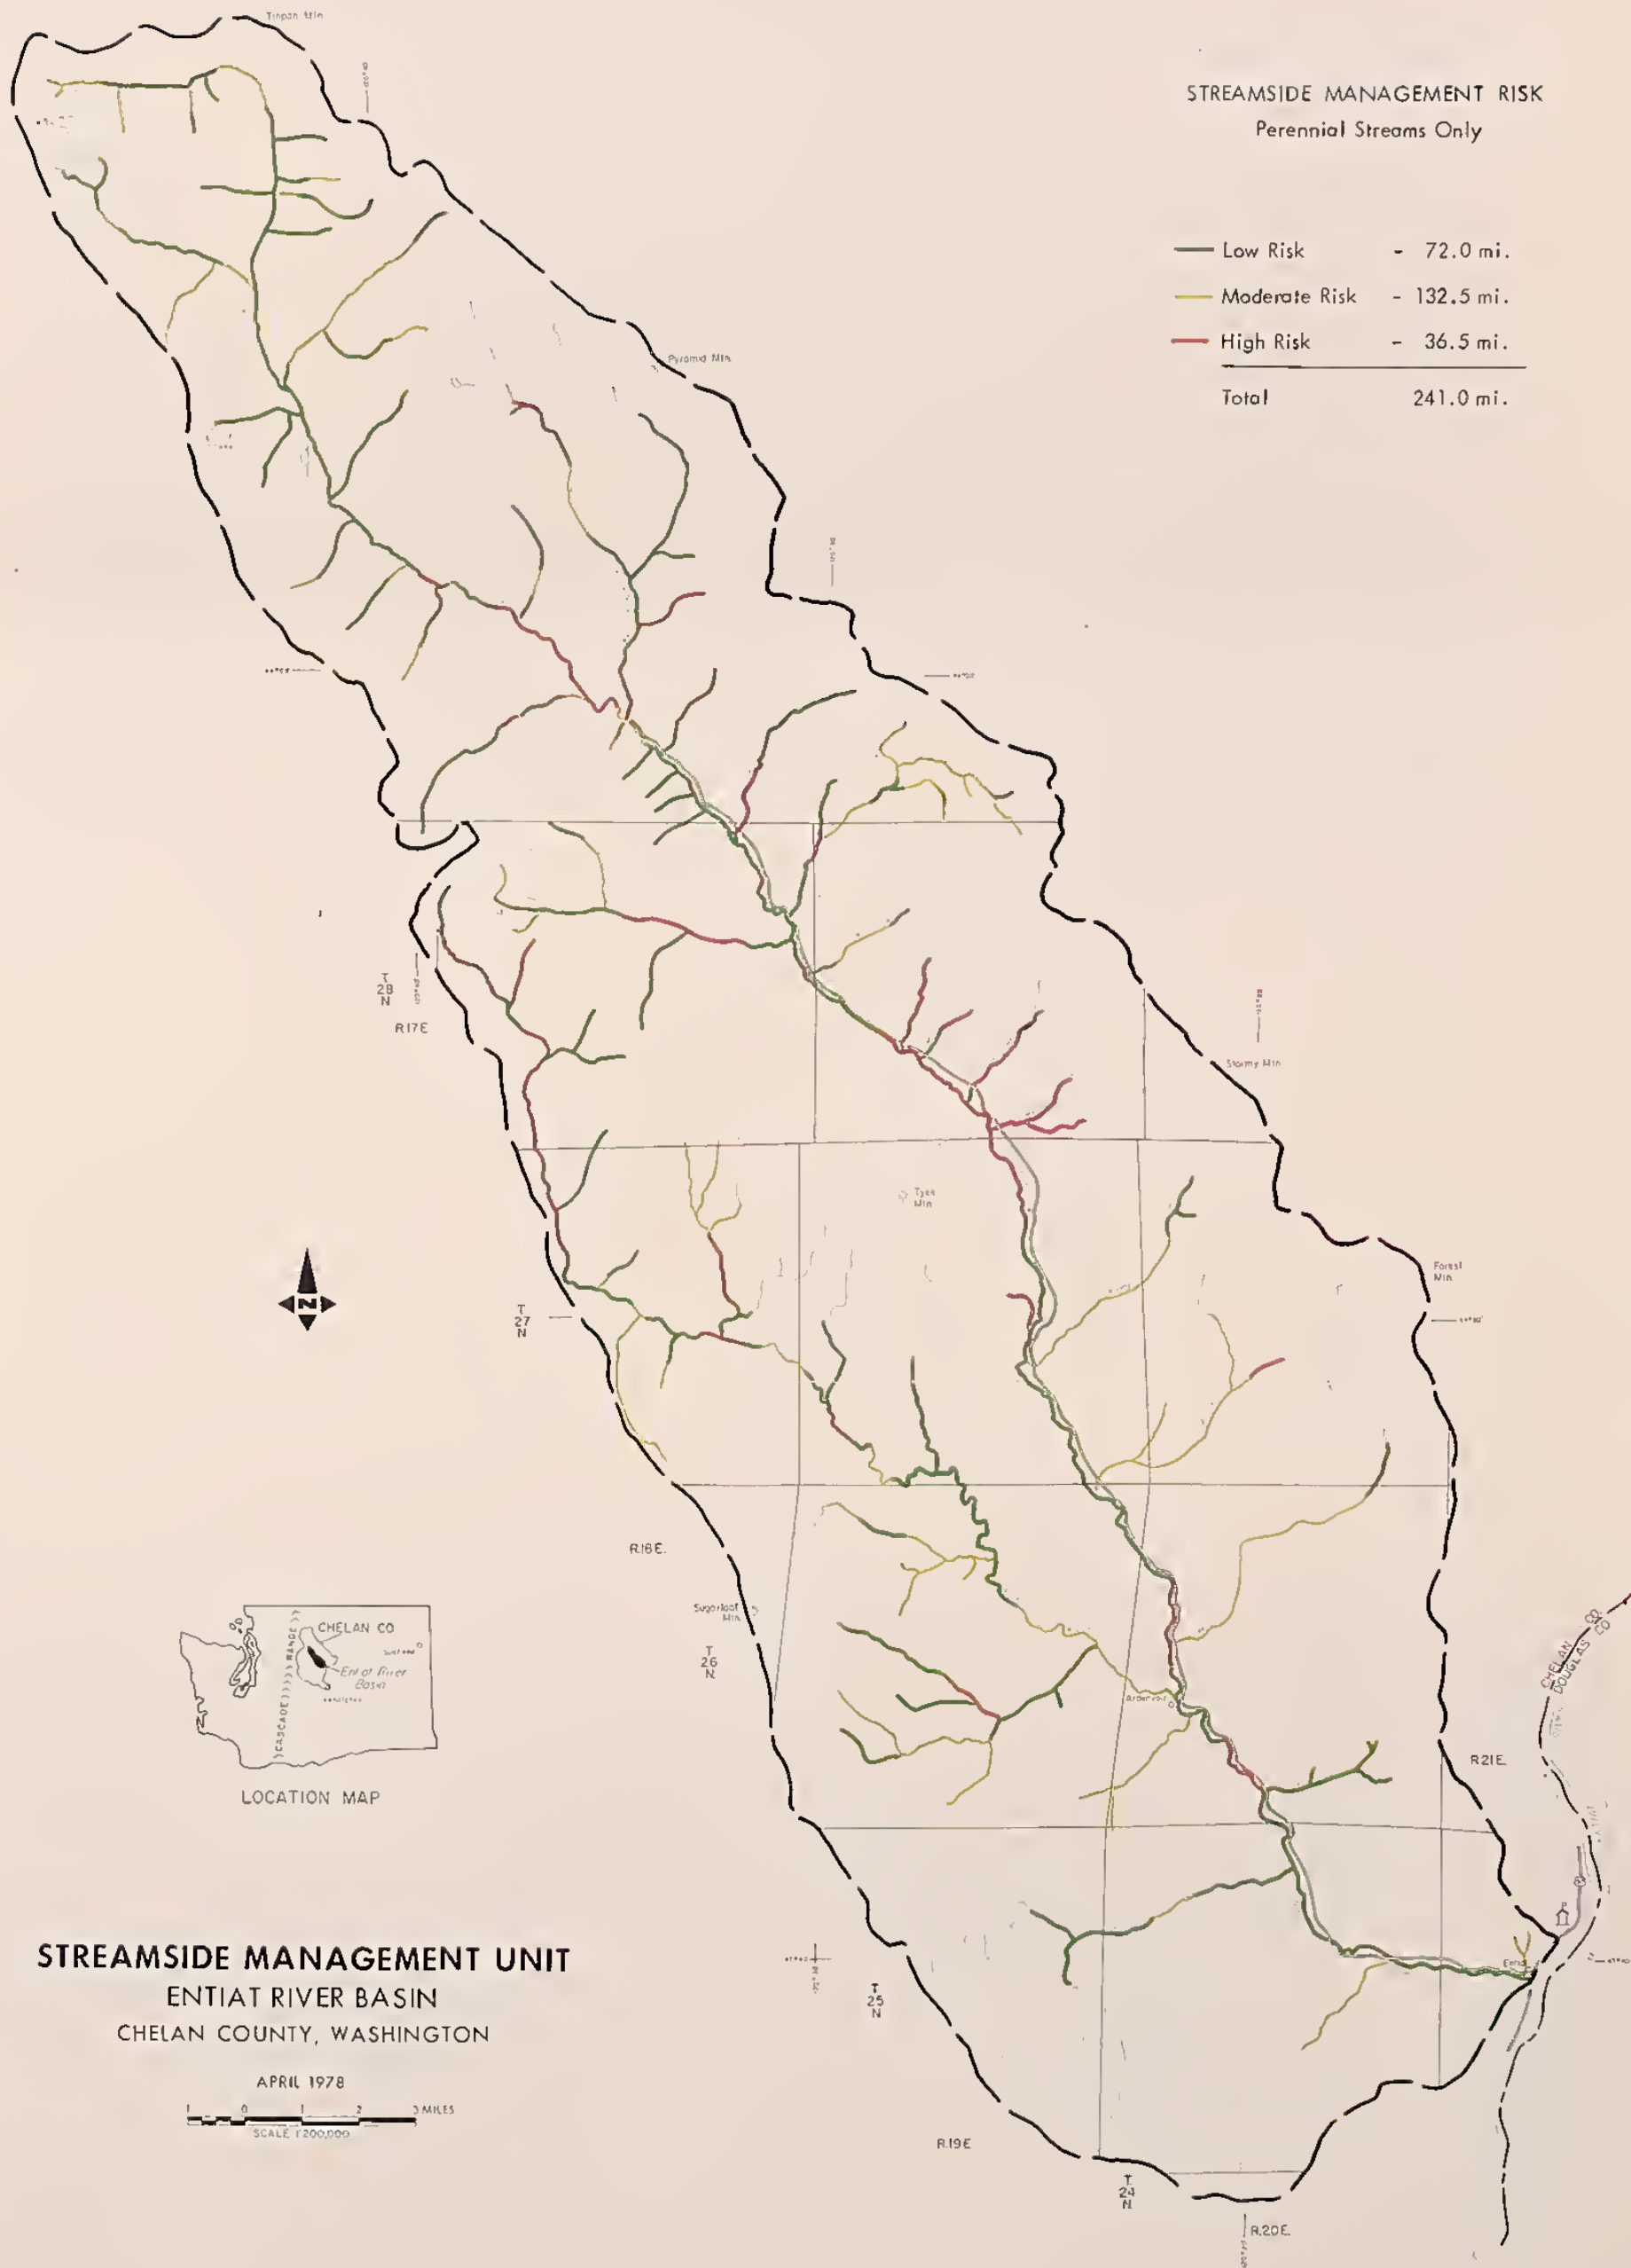
STREAMSIDE MANAGEMENT UNIT ENTIAT RIVER BASIN CHELAN COUNTY, WASHINGTON

Low Risk	- 72.0 mi.
Moderate Risk	- 132.5 mi.
High Risk	- 36.5 mi.
Total	241.0 mi.

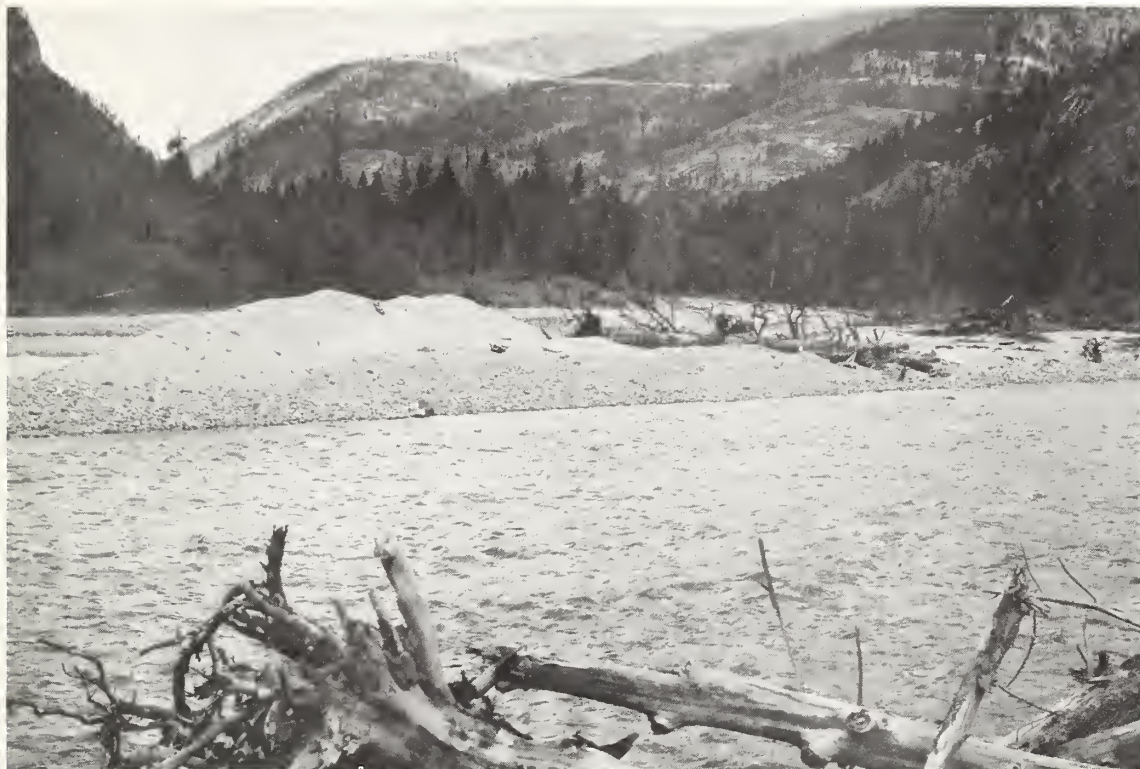
Bedload point bar and log debris in Upper Entiat channel causing streamflow diversion.

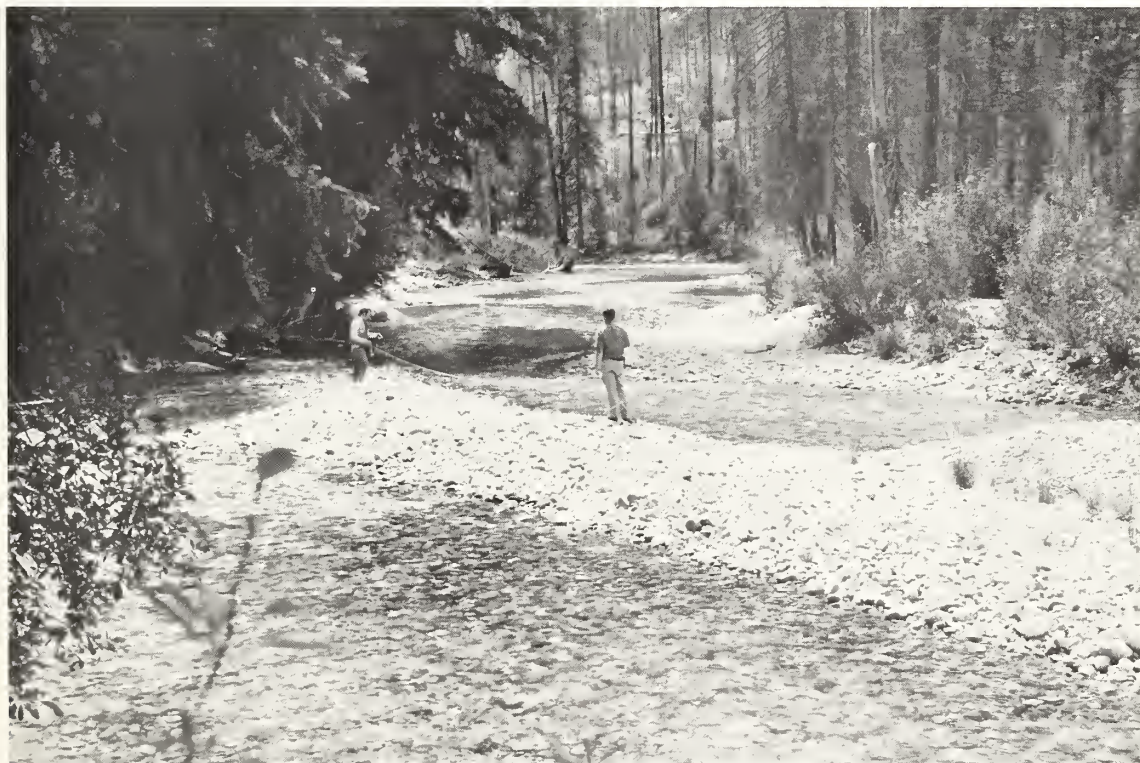
Bedload point bars in Upper Entiat River. Many of these gravels are packed so tight with fine sediment that they have lost fish spawning value.

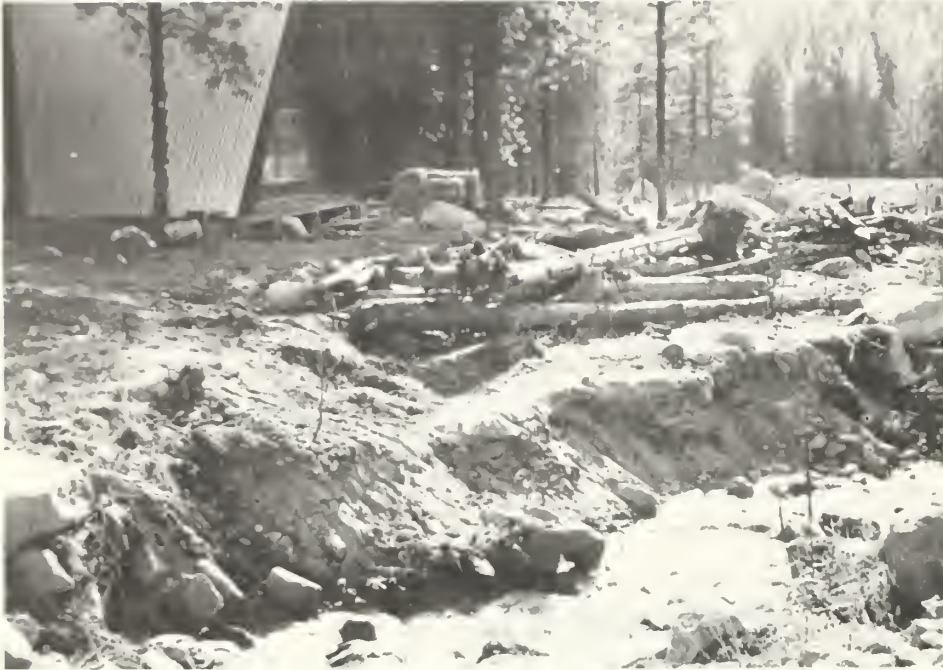
Above — Development of alluvial fan seriously damaged by 1972 flooding. Such areas due to break in slope are natural deposition and water spreading areas.

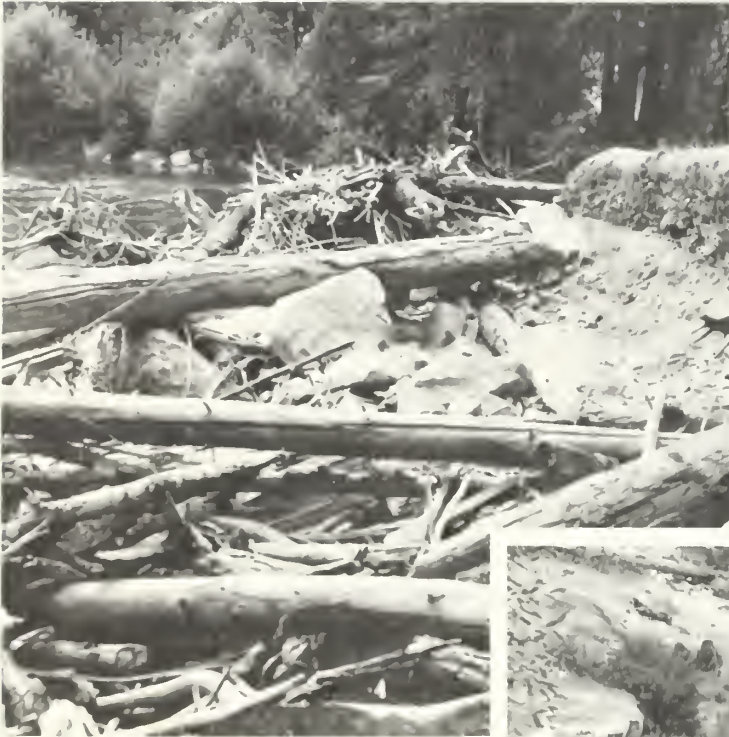
Wood debris from Burn is causing river flow deflection and accelerated bank erosion.

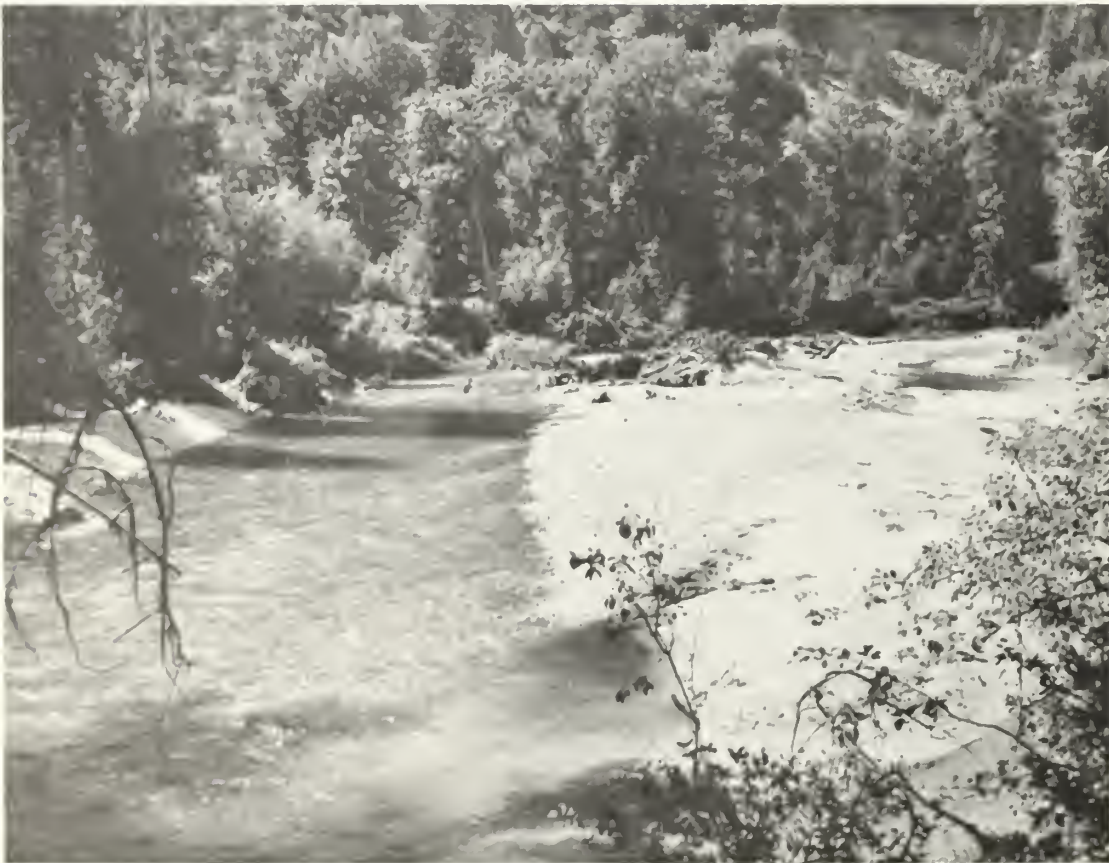
Section of unstable Entiat River; note log debris causing stream flow diversion.

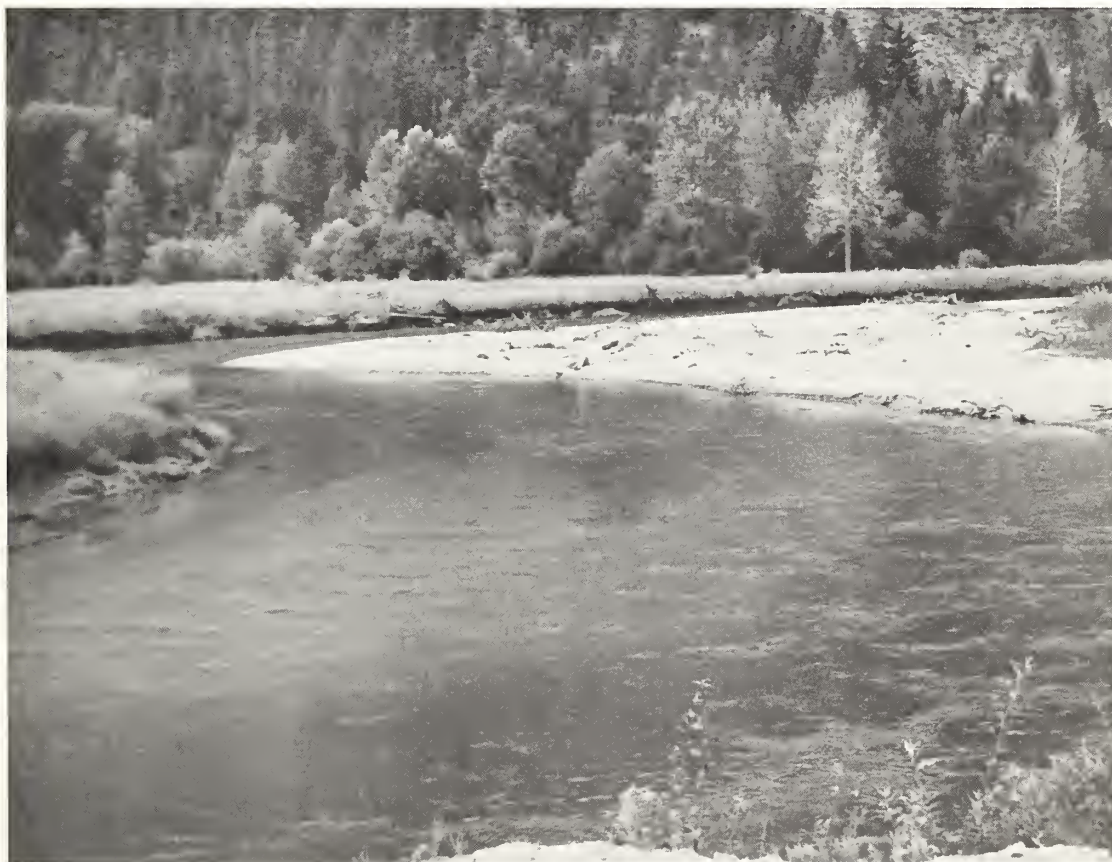
The Mid-Entiat River meanders through a meadow of fine deposits. Banks are very unstable due to lack of rock content and the absence of deeply rooted vegetation.

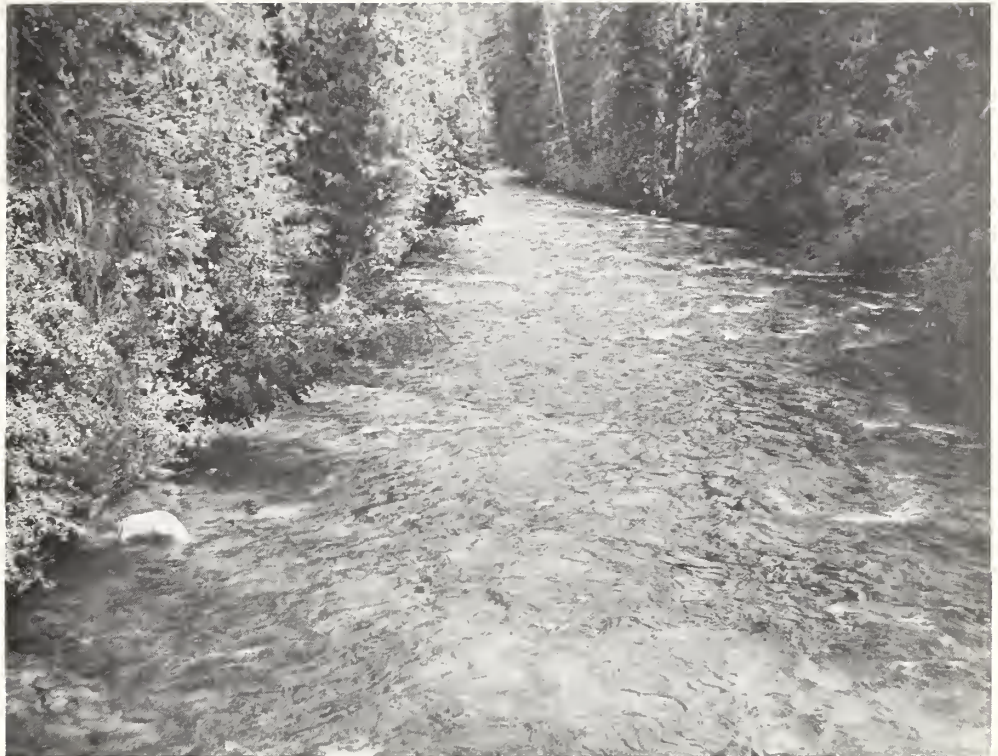
A reach of the Lower Entiat River in excellent stream stability condition. Stream sediment load contribution is only about 1 ton/mile/year.
